**Asbestos Survey Report**

**ASBESTOS SURVEY  
REPORT NO: A-45889 – ISSUE 2**

**Client:**  
PRISTINE LONDON

**Site Address:**  
31 Daleham Gardens  
London  
NW3 5BU

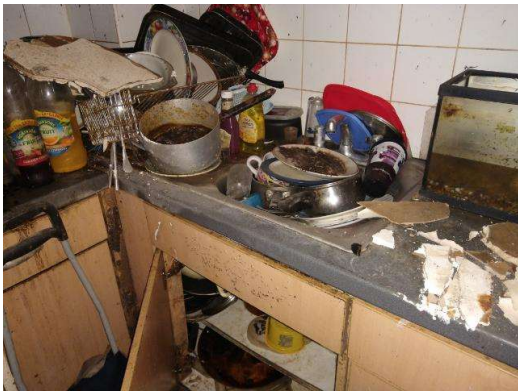
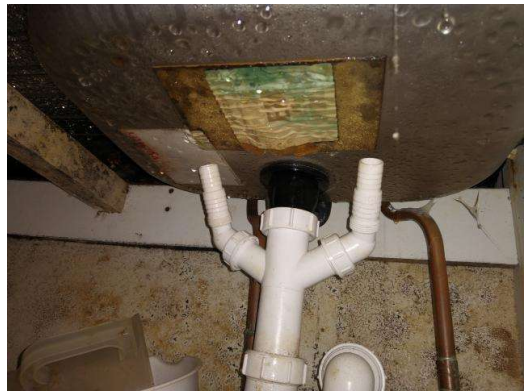
<b>Inspection no:</b>	S001	<b>Type:</b>	Sampled
<b>Room/Area</b>	Basement. Kitchen. [005]		
<b>Location/Element</b>	Sink.		
<b>Notes</b>			
<b>Product Type</b>	N/A	<b>Score:</b>	N/A
<b>Damage/Deterioration</b>	N/A	<b>Score:</b>	N/A
<b>Surface Treatment</b>	N/A	<b>Score:</b>	N/A
<b>Asbestos Type</b>	NAD	<b>Score:</b>	N/A
<b>Extent</b>	0.02 m <sup>2</sup>		
<b>Recommended Action</b>	N/A	<b>Total Score</b>	0

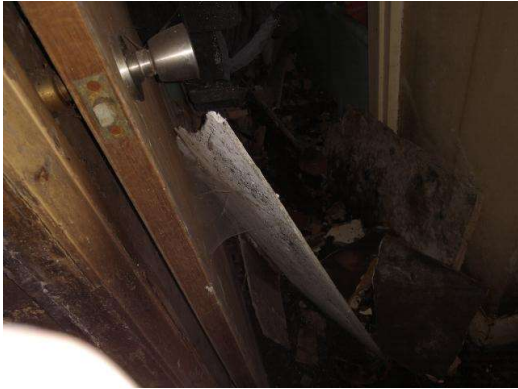
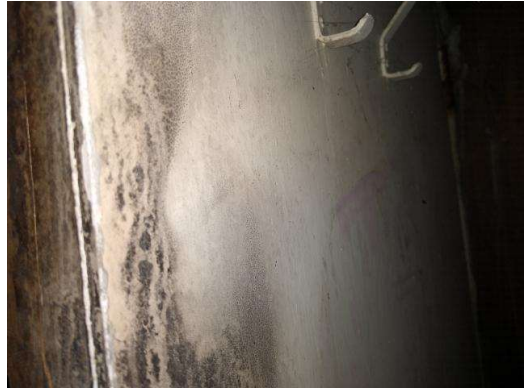
<b>Inspection no:</b>	R004	<b>Type:</b>	Referred Sample
<b>Room/Area</b>	Ground Floor. Communal Corridor. [012]		
<b>Location/Element</b>	Security office entrance door.		
<b>Notes</b>			
<b>Product Type</b>	Insulating Board	<b>Score:</b>	2
<b>Damage/Deterioration</b>	High Damage	<b>Score:</b>	3
<b>Surface Treatment</b>	Partially Unsealed	<b>Score:</b>	2
<b>Asbestos Type</b>	<b>Amosite, Chrysotile</b>	<b>Score:</b>	2
<b>Extent</b>	2 m <sup>2</sup>		
<b>Recommended Action</b>	<b>Remove</b>	<b>Total Score</b>	9

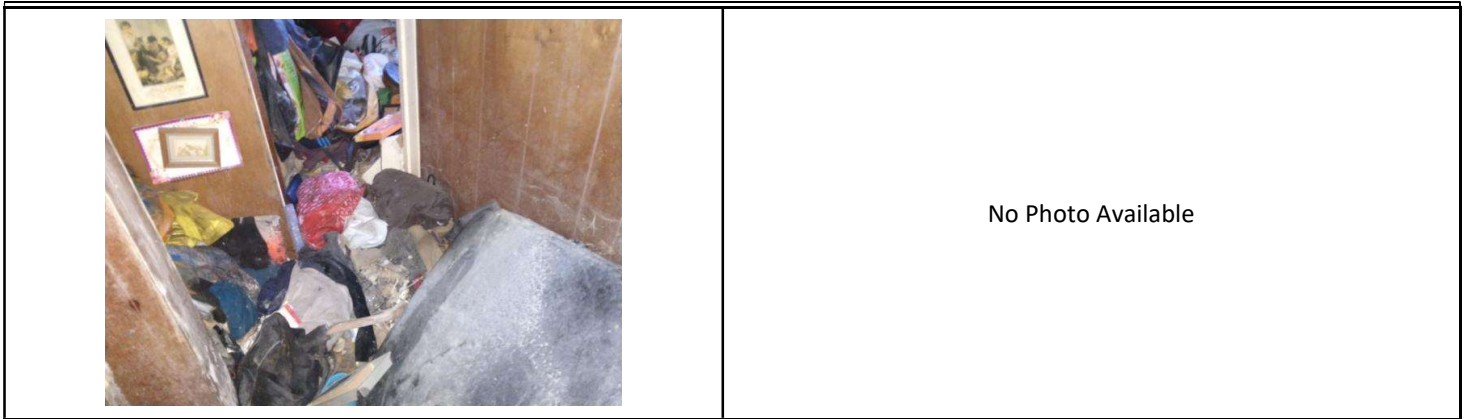
<b>Inspection no:</b>	R004	<b>Type:</b>	Referred Sample
<b>Room/Area</b>	Ground Floor. Communal Corridor. [012]		
<b>Location/Element</b>	Flat 7 entrance door. Floor.		
<b>Notes</b>	Unable to move door due to contamination concerns.		
<b>Product Type</b>	Insulating Board	<b>Score:</b>	2
<b>Damage/Deterioration</b>	High Damage	<b>Score:</b>	3
<b>Surface Treatment</b>	Partially Unsealed	<b>Score:</b>	2
<b>Asbestos Type</b>	<b>Amosite, Chrysotile</b>	<b>Score:</b>	2
<b>Extent</b>	2 m <sup>2</sup>		
<b>Recommended Action</b>	<b>Remove</b>	<b>Total Score</b>	9

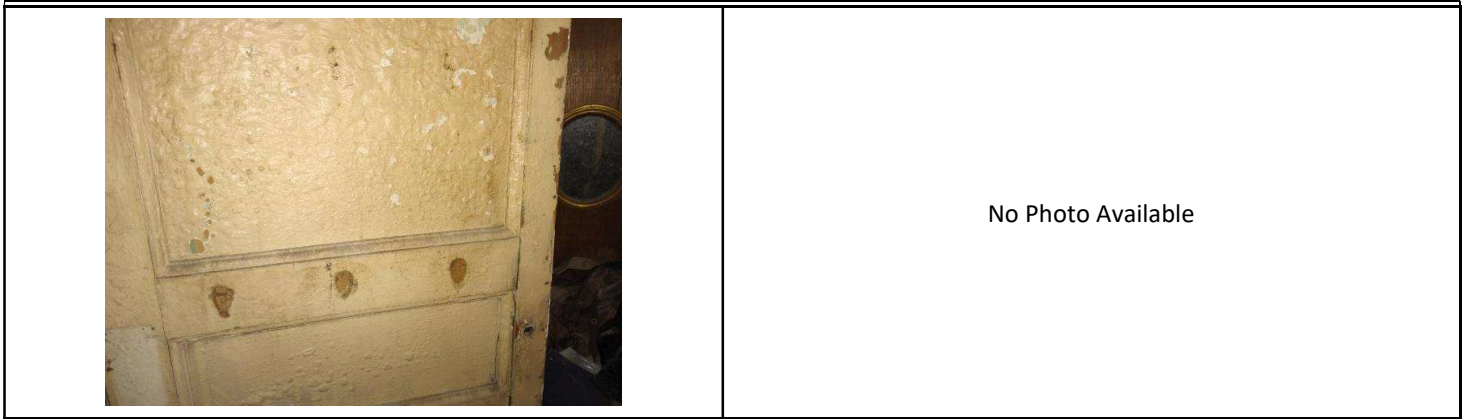
<b>Inspection no:</b>	S004	<b>Type:</b>	Sampled
<b>Room/Area</b>	Ground Floor. Communal Corridor. [012]		
<b>Location/Element</b>	Flat 7 entrance door.		
<b>Notes</b>	Rear of door.		
<b>Product Type</b>	Insulating Board	<b>Score:</b>	2
<b>Damage/Deterioration</b>	High Damage	<b>Score:</b>	3
<b>Surface Treatment</b>	Partially Unsealed	<b>Score:</b>	2
<b>Asbestos Type</b>	<b>Amosite, Chrysotile</b>	<b>Score:</b>	2
<b>Extent</b>	2 m <sup>2</sup>		
<b>Recommended Action</b>	<b>Remove</b>	<b>Total Score</b>	9

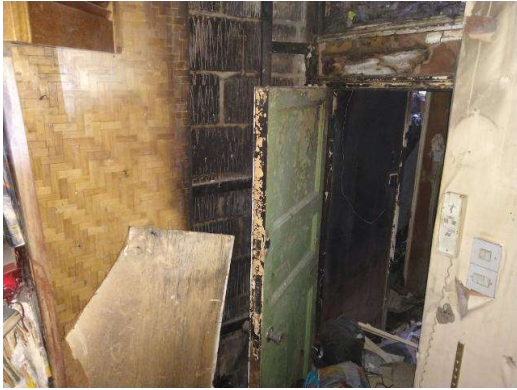
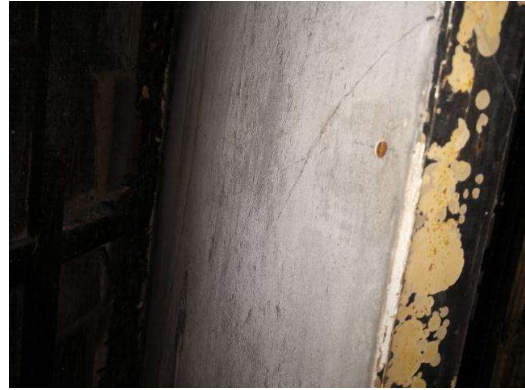
<b>Inspection no:</b>	R003	<b>Type:</b>	Referred Sample
<b>Room/Area</b>	Ground Floor. Flat 6 Bed/Sitting Room. [015]		
<b>Location/Element</b>	Front door.		
<b>Notes</b>			
<b>Product Type</b>	Insulating Board	<b>Score:</b>	2
<b>Damage/Deterioration</b>	High Damage	<b>Score:</b>	3
<b>Surface Treatment</b>	Partially Unsealed	<b>Score:</b>	2
<b>Asbestos Type</b>	<b>Amosite, Chrysotile</b>	<b>Score:</b>	2
<b>Extent</b>	2 no		
<b>Recommended Action</b>	<b>Remove</b>	<b>Total Score</b>	9

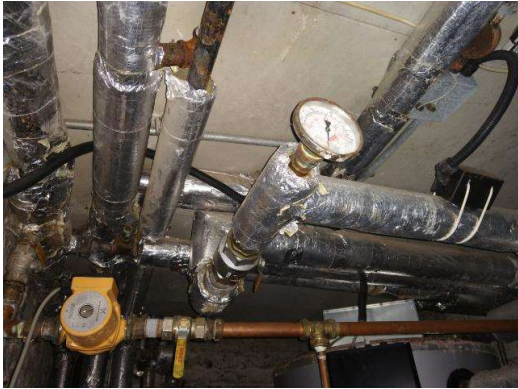
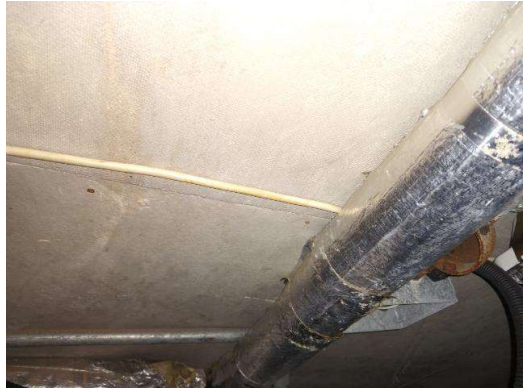
<b>Inspection no:</b>	S007	<b>Type:</b>	Sampled
<b>Room/Area</b>	Basement. Boiler Room. [017]		
<b>Location/Element</b>	Ceiling.		
<b>Notes</b>			
<b>Product Type</b>	N/A	<b>Score:</b>	N/A
<b>Damage/Deterioration</b>	N/A	<b>Score:</b>	N/A
<b>Surface Treatment</b>	N/A	<b>Score:</b>	N/A
<b>Asbestos Type</b>	NAD	<b>Score:</b>	N/A
<b>Extent</b>	8 m <sup>2</sup>		
<b>Recommended Action</b>	N/A	<b>Total Score</b>	0

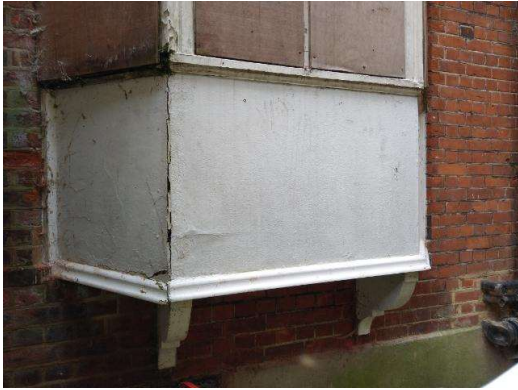
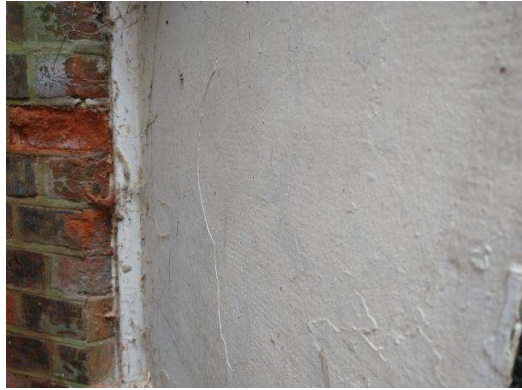
<b>Inspection no:</b>	S006	<b>Type:</b>	Sampled
<b>Room/Area</b>	Ground Floor. External. [018]		
<b>Location/Element</b>	Bay window panels.		
<b>Notes</b>			
<b>Product Type</b>	Cement	<b>Score:</b>	1
<b>Damage/Deterioration</b>	Medium Damage	<b>Score:</b>	2
<b>Surface Treatment</b>	Sealed	<b>Score:</b>	1
<b>Asbestos Type</b>	<b>Chrysotile</b>	<b>Score:</b>	1
<b>Extent</b>	2.5 m <sup>2</sup>		
<b>Recommended Action</b>	<b>Remove</b>	<b>Total Score</b>	5

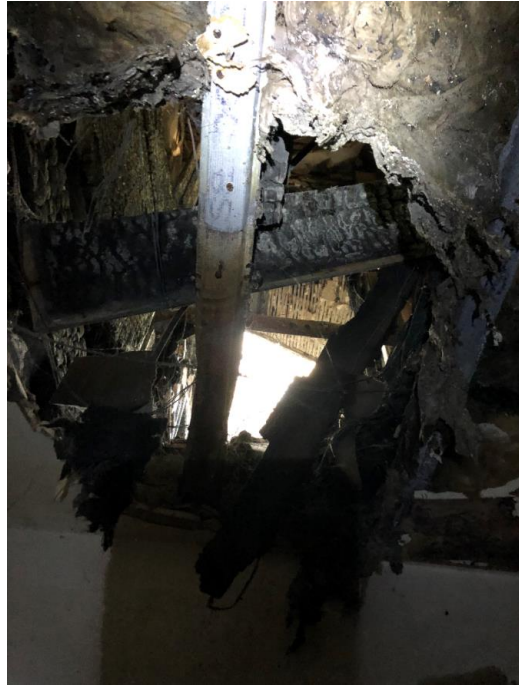
Photo 1 - Apartment 1 fire damage to stair above kitchen

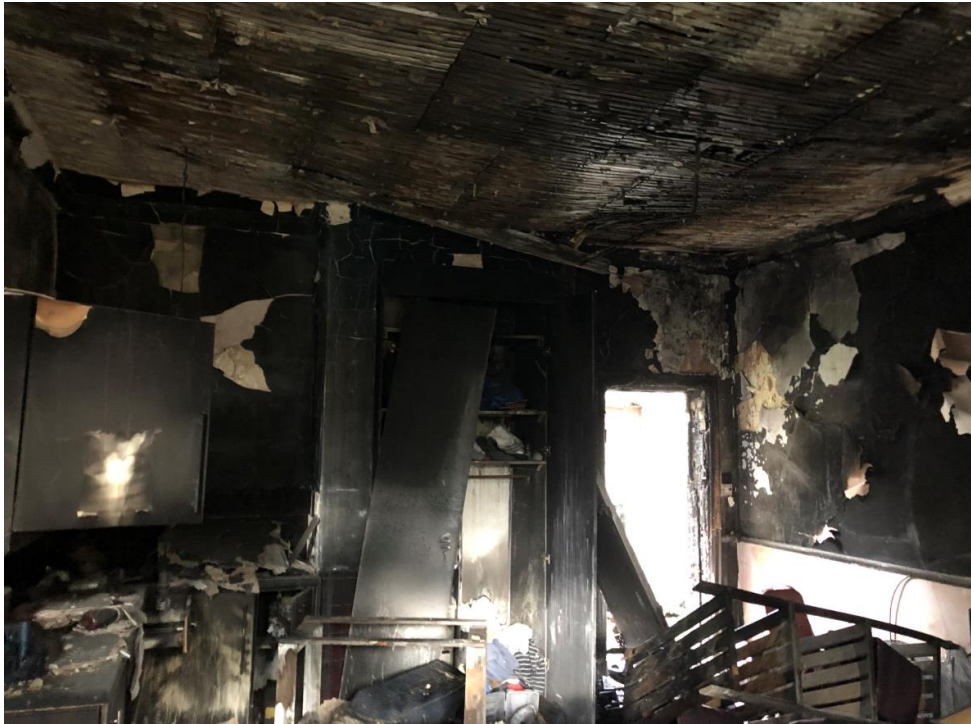
Photo 28 - sagging trimmer joist at second floor level above Apartment 9
