**Asbestos Survey Report**

**ASBESTOS SURVEY  
REPORT NO: A-45889 – ISSUE 2**

**Client:**  
PRISTINE LONDON

**Site Address:**  
31 Daleham Gardens  
London  
NW3 5BU

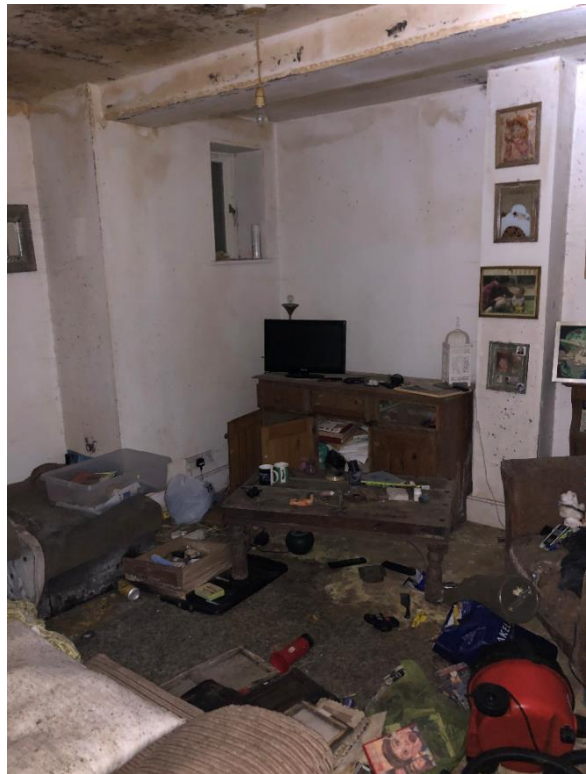
Photo 4 - Apartment 1 living room

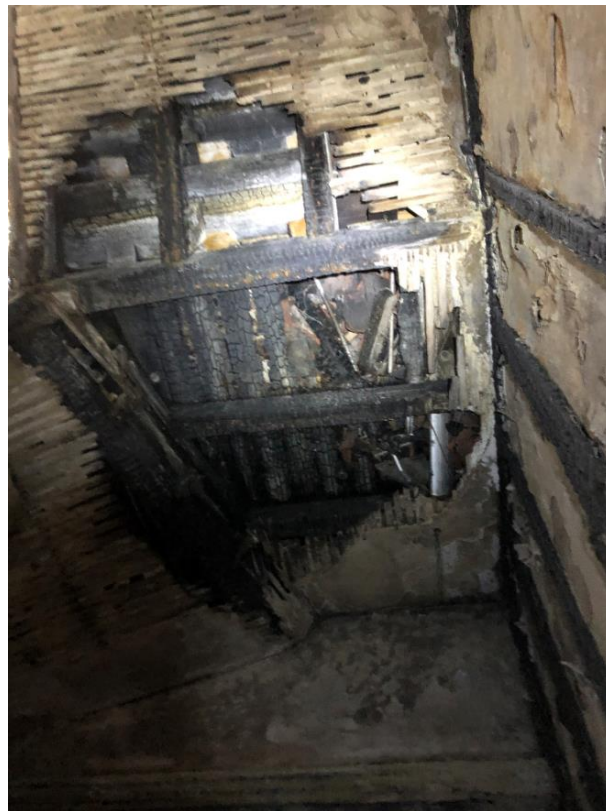
Photo 6 - Apartment 1 bedroom 3 cupboard  
underside of stair

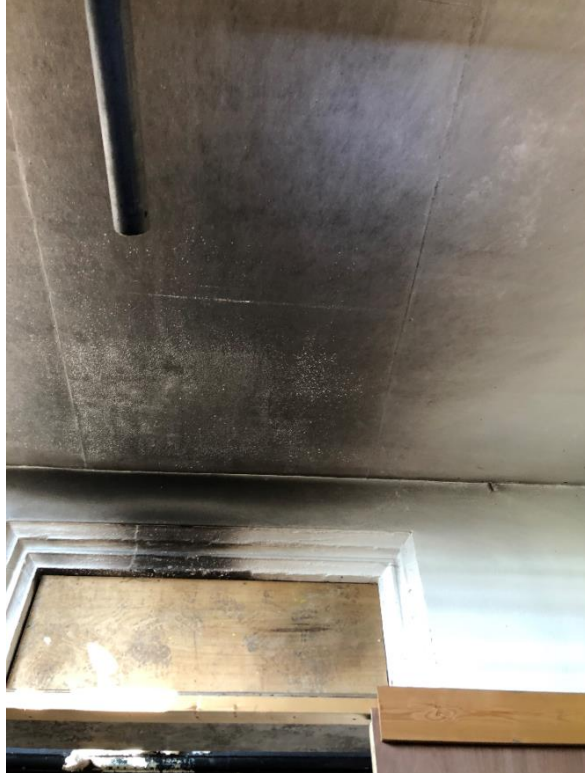
Photo 7 - Main entrance porch

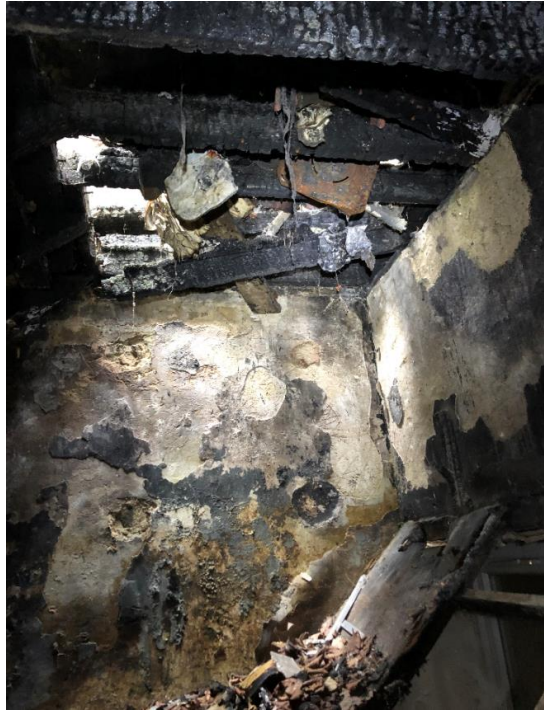
Photo 15 - Stair from ground to first floor underside of half landing

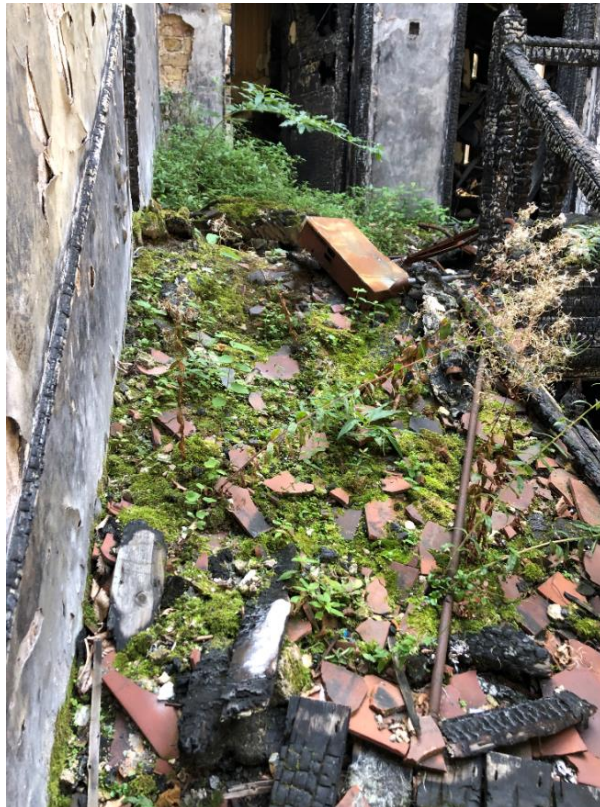
Photo 16 - Stair from ground floor to first floor

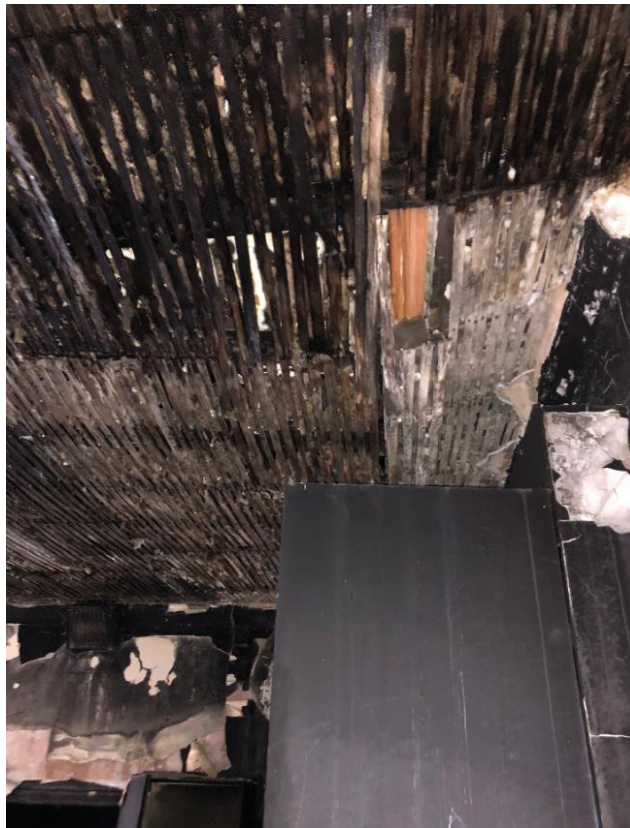
The second floor above apartment 9 is of timber joist construction. The second floor is sagging due to a trimmer joist around the chimney breast becoming disconnected at one end as shown in photographs 28 and 29. This trimmer joist should be propped down to the top of the basement retaining wall using a single Acrow prop at each level with double scaffold board spreader plates above and below the first floor joists.

Photo 29 - sagging trimmer joist at second floor level above Apartment 9

*Second floor  
Trimmer joist  
to be  
propped with  
single Acrow  
prop down to  
basement retaining  
wall.*

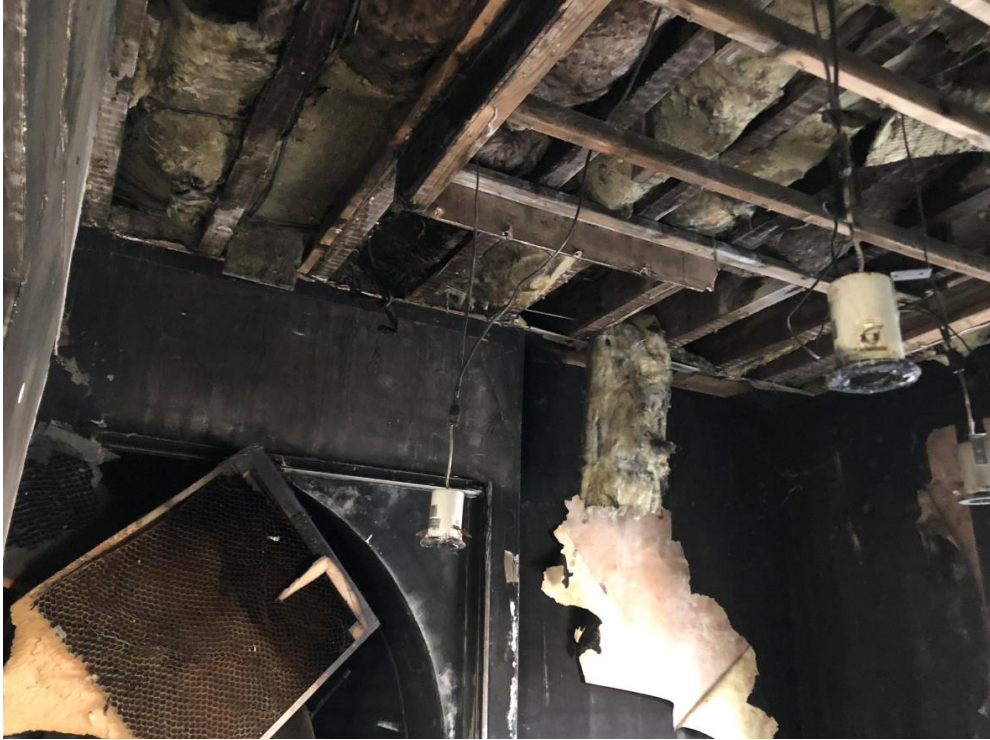
The second floor above apartment 8 is of timber joist construction. Refer to photographs 30 and 31 for general views of this apartment.

Photo 30 - Timber joists at second floor above apartment 8
