**Asbestos Survey Report**

**ASBESTOS SURVEY  
REPORT NO: A-45889 – ISSUE 2**

**Client:**  
PRISTINE LONDON

**Site Address:**  
31 Daleham Gardens  
London  
NW3 5BU

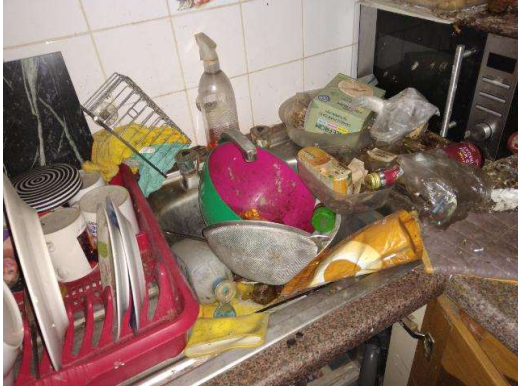
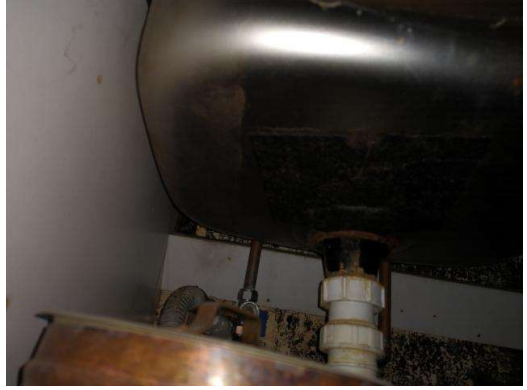
<b>Inspection no:</b>	S002	<b>Type:</b>	Sampled
<b>Room/Area</b>	Ground Floor. Flat 4 Kitchen. [010]		
<b>Location/Element</b>	Sink.		
<b>Notes</b>			
<b>Product Type</b>	N/A	<b>Score:</b>	N/A
<b>Damage/Deterioration</b>	N/A	<b>Score:</b>	N/A
<b>Surface Treatment</b>	N/A	<b>Score:</b>	N/A
<b>Asbestos Type</b>	<b>NAD</b>	<b>Score:</b>	N/A
<b>Extent</b>	0.02 m <sup>2</sup>		
<b>Recommended Action</b>	<b>N/A</b>	<b>Total Score</b>	0

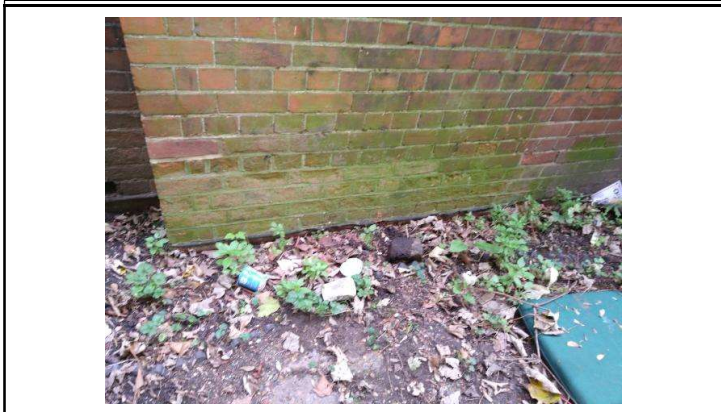
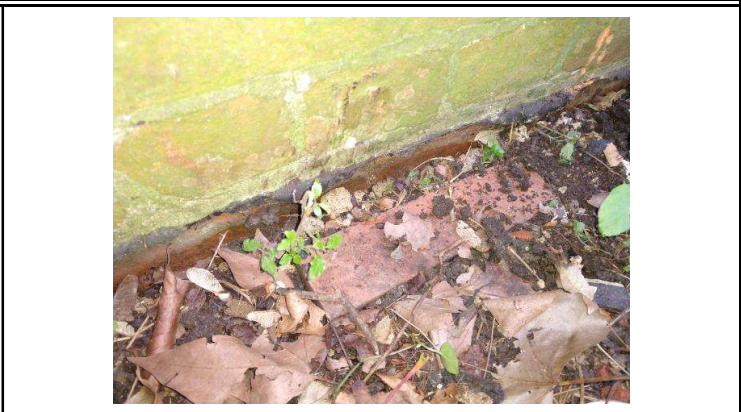
<b>Inspection no:</b>	S005	<b>Type:</b>	Sampled
<b>Room/Area</b>	Ground Floor. External. [018]		
<b>Location/Element</b>	Walls.		
<b>Notes</b>			
<b>Product Type</b>	N/A	<b>Score:</b>	N/A
<b>Damage/Deterioration</b>	N/A	<b>Score:</b>	N/A
<b>Surface Treatment</b>	N/A	<b>Score:</b>	N/A
<b>Asbestos Type</b>	NAD	<b>Score:</b>	N/A
<b>Extent</b>	80 lin m		
<b>Recommended Action</b>	N/A	<b>Total Score</b>	0

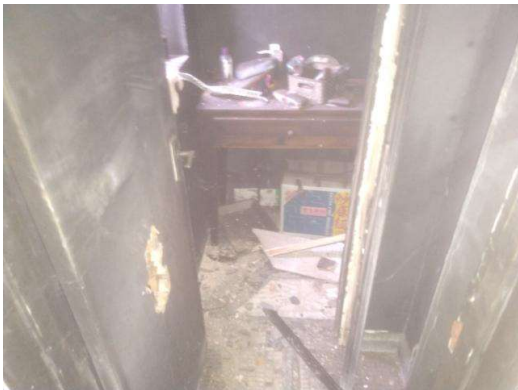
<b>Inspection no:</b>	S006	<b>Type:</b>	Sampled
<b>Room/Area</b>	Ground Floor. External. [018]		
<b>Location/Element</b>	Bay window panels.		
<b>Notes</b>			
<b>Product Type</b>	Cement	<b>Score:</b>	1
<b>Damage/Deterioration</b>	Medium Damage	<b>Score:</b>	2
<b>Surface Treatment</b>	Sealed	<b>Score:</b>	1
<b>Asbestos Type</b>	<b>Chrysotile</b>	<b>Score:</b>	1
<b>Extent</b>	2.5 m <sup>2</sup>		
<b>Recommended Action</b>	<b>Remove</b>	<b>Total Score</b>	5

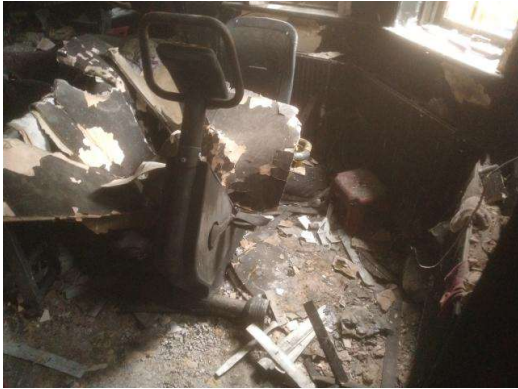
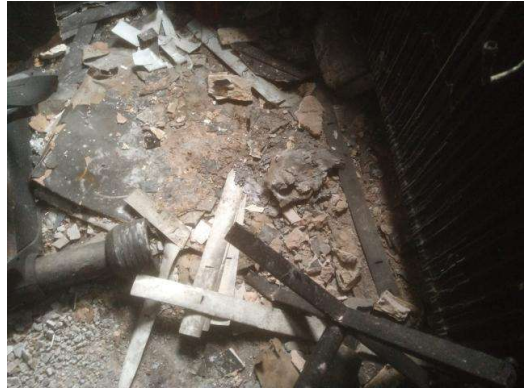
<b>Inspection no:</b>	S008	<b>Type:</b>	Sampled
<b>Room/Area</b>	1st Floor. Room 09. [019]		
<b>Location/Element</b>	Floor		
<b>Notes</b>			
<b>Product Type</b>	N/A	<b>Score:</b>	N/A
<b>Damage/Deterioration</b>	N/A	<b>Score:</b>	N/A
<b>Surface Treatment</b>	N/A	<b>Score:</b>	N/A
<b>Asbestos Type</b>	NAD	<b>Score:</b>	N/A
<b>Extent</b>	8 m <sup>2</sup>		
<b>Recommended Action</b>	N/A	<b>Total Score</b>	0

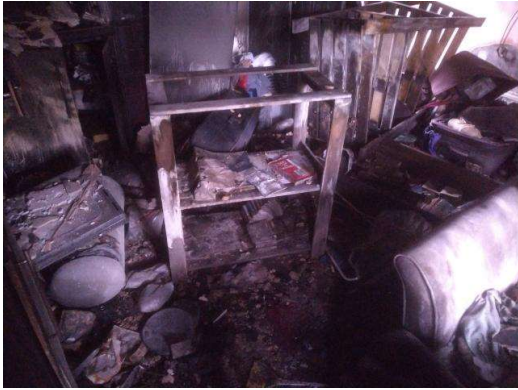
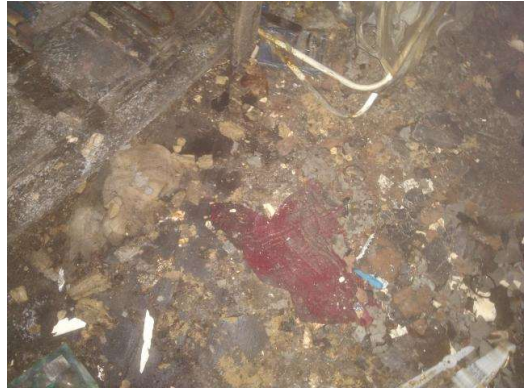
<b>Inspection no:</b>	S009	<b>Type:</b>	Sampled
<b>Room/Area</b>	1st Floor. Room 09. [019]		
<b>Location/Element</b>	Floor		
<b>Notes</b>			
<b>Product Type</b>	N/A	<b>Score:</b>	N/A
<b>Damage/Deterioration</b>	N/A	<b>Score:</b>	N/A
<b>Surface Treatment</b>	N/A	<b>Score:</b>	N/A
<b>Asbestos Type</b>	NAD	<b>Score:</b>	N/A
<b>Extent</b>	8 m <sup>2</sup>		
<b>Recommended Action</b>	N/A	<b>Total Score</b>	0

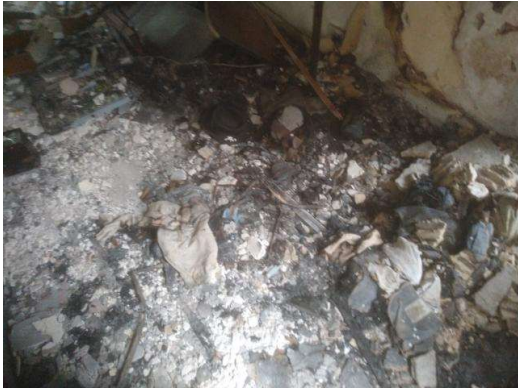
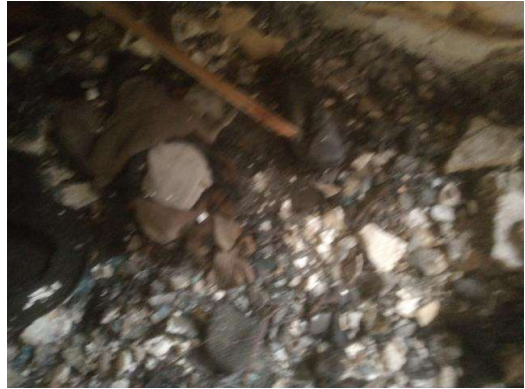
<b>Inspection no:</b>	S010	<b>Type:</b>	Sampled
<b>Room/Area</b>	1st Floor. Room 10. [020]		
<b>Location/Element</b>	Floor		
<b>Notes</b>			
<b>Product Type</b>	N/A	<b>Score:</b>	N/A
<b>Damage/Deterioration</b>	N/A	<b>Score:</b>	N/A
<b>Surface Treatment</b>	N/A	<b>Score:</b>	N/A
<b>Asbestos Type</b>	NAD	<b>Score:</b>	N/A
<b>Extent</b>	8 m <sup>2</sup>		
<b>Recommended Action</b>	N/A	<b>Total Score</b>	0

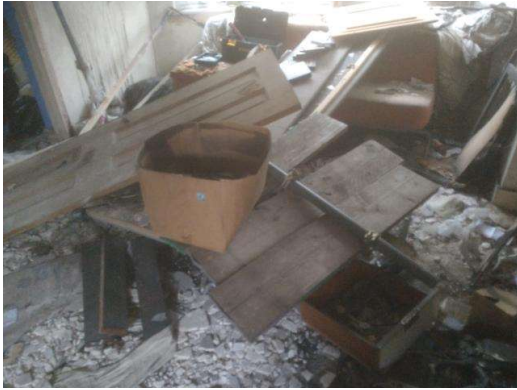
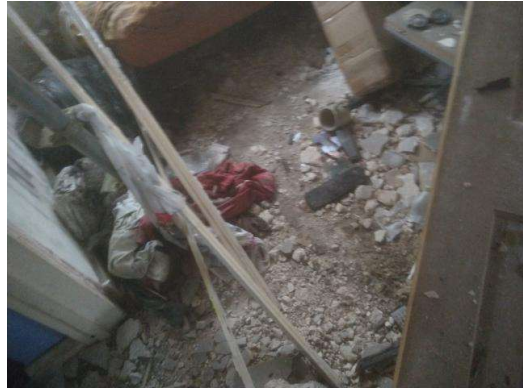
<b>Inspection no:</b>	S011	<b>Type:</b>	Sampled
<b>Room/Area</b>	1st Floor. Room 10. [020]		
<b>Location/Element</b>	Floor		
<b>Notes</b>			
<b>Product Type</b>	N/A	<b>Score:</b>	N/A
<b>Damage/Deterioration</b>	N/A	<b>Score:</b>	N/A
<b>Surface Treatment</b>	N/A	<b>Score:</b>	N/A
<b>Asbestos Type</b>	<b>NAD</b>	<b>Score:</b>	N/A
<b>Extent</b>	8 m <sup>2</sup>		
<b>Recommended Action</b>	<b>N/A</b>	<b>Total Score</b>	0

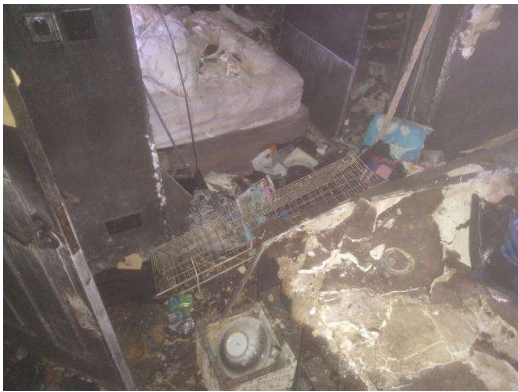
<b>Inspection no:</b>	S012	<b>Type:</b>	Sampled
<b>Room/Area</b>	1st Floor. Room 08. [021]		
<b>Location/Element</b>	Floor		
<b>Notes</b>			
<b>Product Type</b>	N/A	<b>Score:</b>	N/A
<b>Damage/Deterioration</b>	N/A	<b>Score:</b>	N/A
<b>Surface Treatment</b>	N/A	<b>Score:</b>	N/A
<b>Asbestos Type</b>	NAD	<b>Score:</b>	N/A
<b>Extent</b>	8 m <sup>2</sup>		
<b>Recommended Action</b>	N/A	<b>Total Score</b>	0

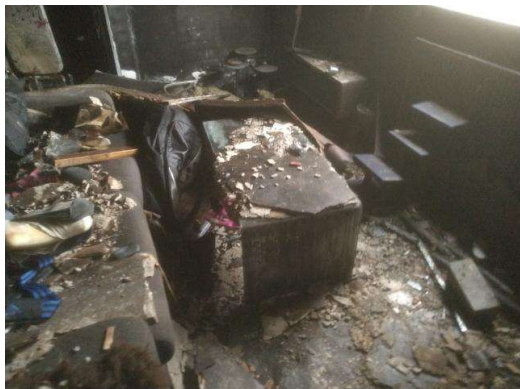
<b>Inspection no:</b>	S013	<b>Type:</b>	Sampled
<b>Room/Area</b>	1st Floor. Room 08. [021]		
<b>Location/Element</b>	Floor		
<b>Notes</b>			
<b>Product Type</b>	N/A	<b>Score:</b>	N/A
<b>Damage/Deterioration</b>	N/A	<b>Score:</b>	N/A
<b>Surface Treatment</b>	N/A	<b>Score:</b>	N/A
<b>Asbestos Type</b>	<b>NAD</b>	<b>Score:</b>	N/A
<b>Extent</b>	8 m <sup>2</sup>		
<b>Recommended Action</b>	<b>N/A</b>	<b>Total Score</b>	0

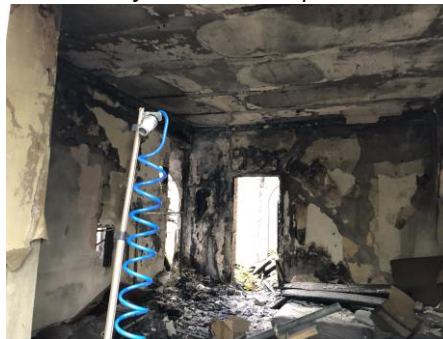
Photo 7213

1. *This apartment is safe to access via the scaffolding and through the window.*
2. *There is fire damage to the first floor near the entrance door from the main stair landing. A 1.5m x 1.5m exclusion zone should be provided here.*
3. *The timber stud wall between apartment 10 and 11 has fire damage. Please avoid leaning against this wall. Refer to attached photo 7213.*

4. *The roof above this apartment is of filler joist concrete slab construction. This has not been structurally damaged by the fire but is suffering from water penetration. Refer to attached photo 7213.*
5. *There is a steel beam located above the stud wall between apartment 10 and 11. Refer to attached photo 7217.*

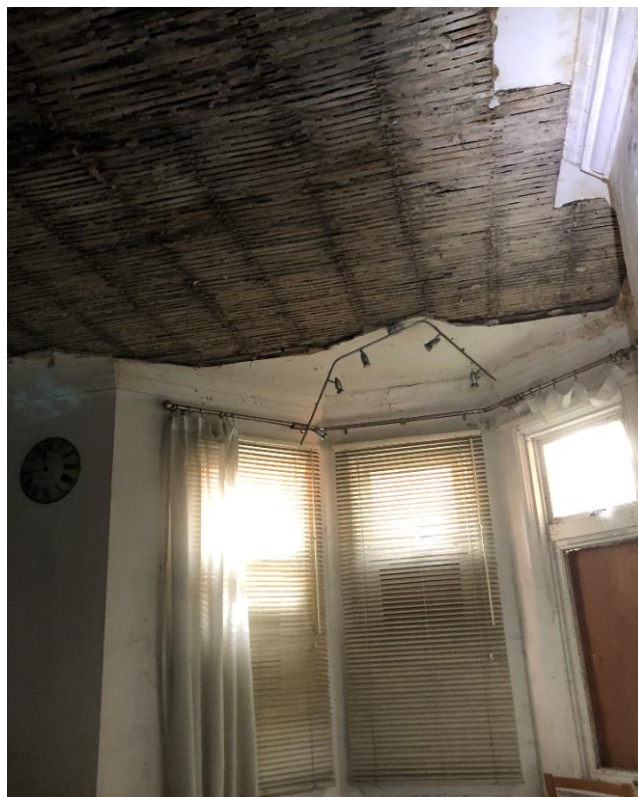
Photo 12 - Apartment 5 bed/sitting room
